St. Croix East End Watersheds Existing Conditions Report

July 2011

Prepared by:
Horsley Witten Group, Inc
90 Route 6A, Sandwich, MA, 02563
508-833-6600
www.horsleywitten.com

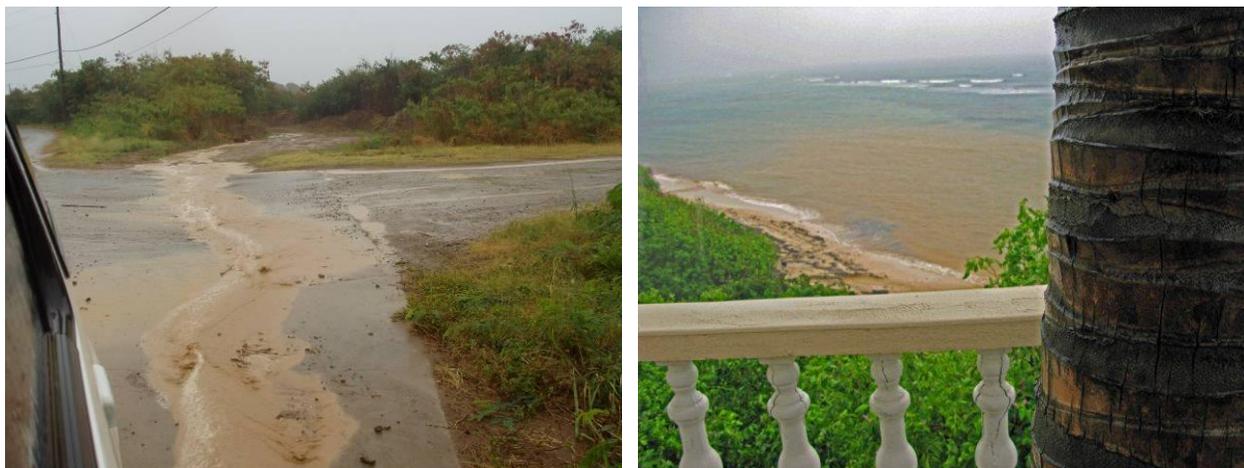
Stormwater runoff across unpaved roads, construction sites, or other bare soils can discharge turbid plumes into nearshore waters even during average rain events (Figure 1.3). Increased runoff volumes from urban development can lead to gut erosion, which can impact gut ecology, contribute to downstream sedimentation, block culverts, and increase the risk of flooding. Trash, oils, and other chemicals that collect on (or are dumped onto) impervious surfaces and in drainage ways can also be transported to marine waters via stormwater runoff. Excess nutrients from septic systems and wastewater discharges can seep into the groundwater or surface drainages, contributing to algal growth and low dissolved oxygen. In some instances, untreated sewage discharges and unmanaged waste from livestock, pets, or wildlife can introduce pathogens, which can lead to beach closures and fishing restrictions.

Figure 1.3. Sediment-laden runoff from unpaved roads in Cotton Valley conveyed in concrete swale (left, photo courtesy of Zandy Hillis-Starr). Uncontrolled runoff resulting in sediment plume in Grapetree Bay during heavy rains in July 2010 (right) (photo courtesy of Kathy LaGrange/Dave Rivers).
